## Stream Segment Evaluation

## BEAL SLOUGH MASTER PLAN

LINCOLN, NEBRASKA

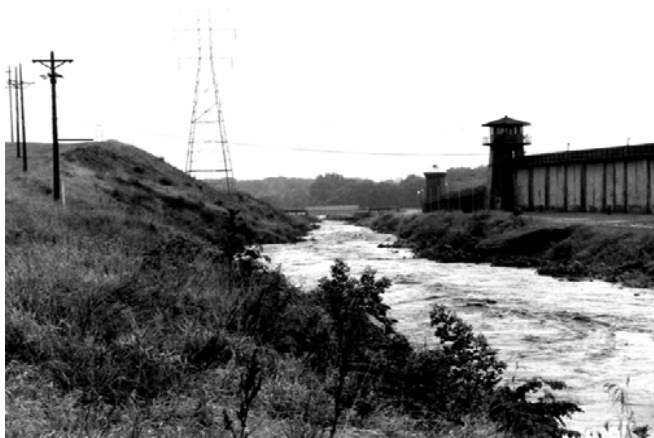
Photograph 1. Looking downstream from Highway 77.

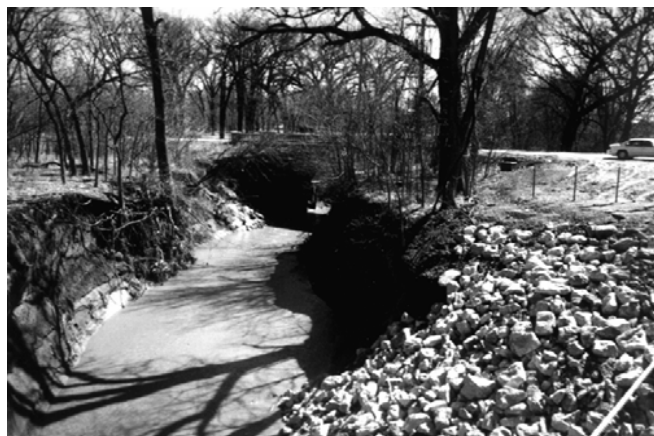
Photograph 2. Looking upstream from the BNSF railroad bridge toward Pioneers Boulevard.

- Reach Stability - The reach from the mouth to the Union Pacific Railroad (UPRR) and Burlington Northern Santa Fe Railroad (BNSFRR) bridges has experienced 2 to 3 feet of bed degradation since 1978. From Pioneers Boulevard bridge to 500 feet upstream, the channel banks have migrated between 10 and 20 feet on the outside radius due to sloughing. The banks are steep and unstable, most likely due to the bed degradation. Near the mouth, a meander on Salt Creek and a meander on Beal Slough are moving toward each other. Salt Creek has migrated and taken over the last 500 feet of the Beal Slough channel.

- Threats to Bridges & Utilities - Unstable banks due to a scour hole near station 55+00 threaten an electrical transmission tower. Channel degradation has exposed the timber piling supporting the Pioneers Boulevard bridge, which is listed as an historic structure.

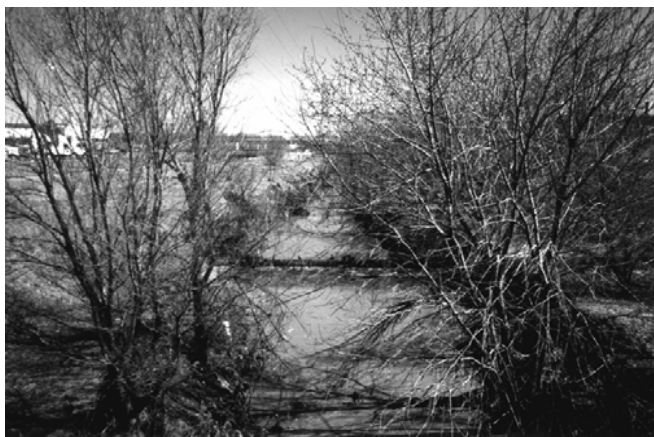
Photograph 3. Looking Upstream from Highway 77.

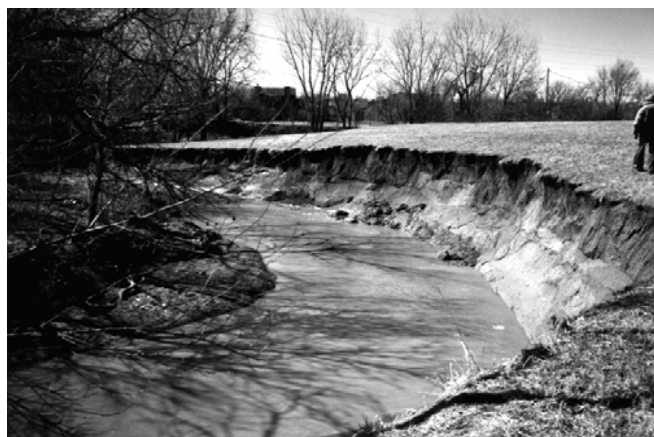
Photograph 4. Looking

downstream from the 27th Street box culvert.

- Reach Stability -** Erosive velocities are evident at the end of the 27th Street box culvert outlet channel. Head cutting is occurring at the railroad spur bridge near Station 90+00. The stream bed grade between Highway 77 and the railroad spur bridge is approximately equal to the stable slope determined for Beal Slough. The Southwood Drive culvert flow line elevation is currently 3 feet above the stream bed elevation for the same point on the FIS stream bed profile, indicating that the stream bed has degraded at this location. The channel slope from Southwood Drive to 27th Street is at or flatter than the stable slope. The box culverts serve as control points for this reach at the upstream and downstream ends. Channel banks are sloughing on the outside radii of meanders due to toe cutting.

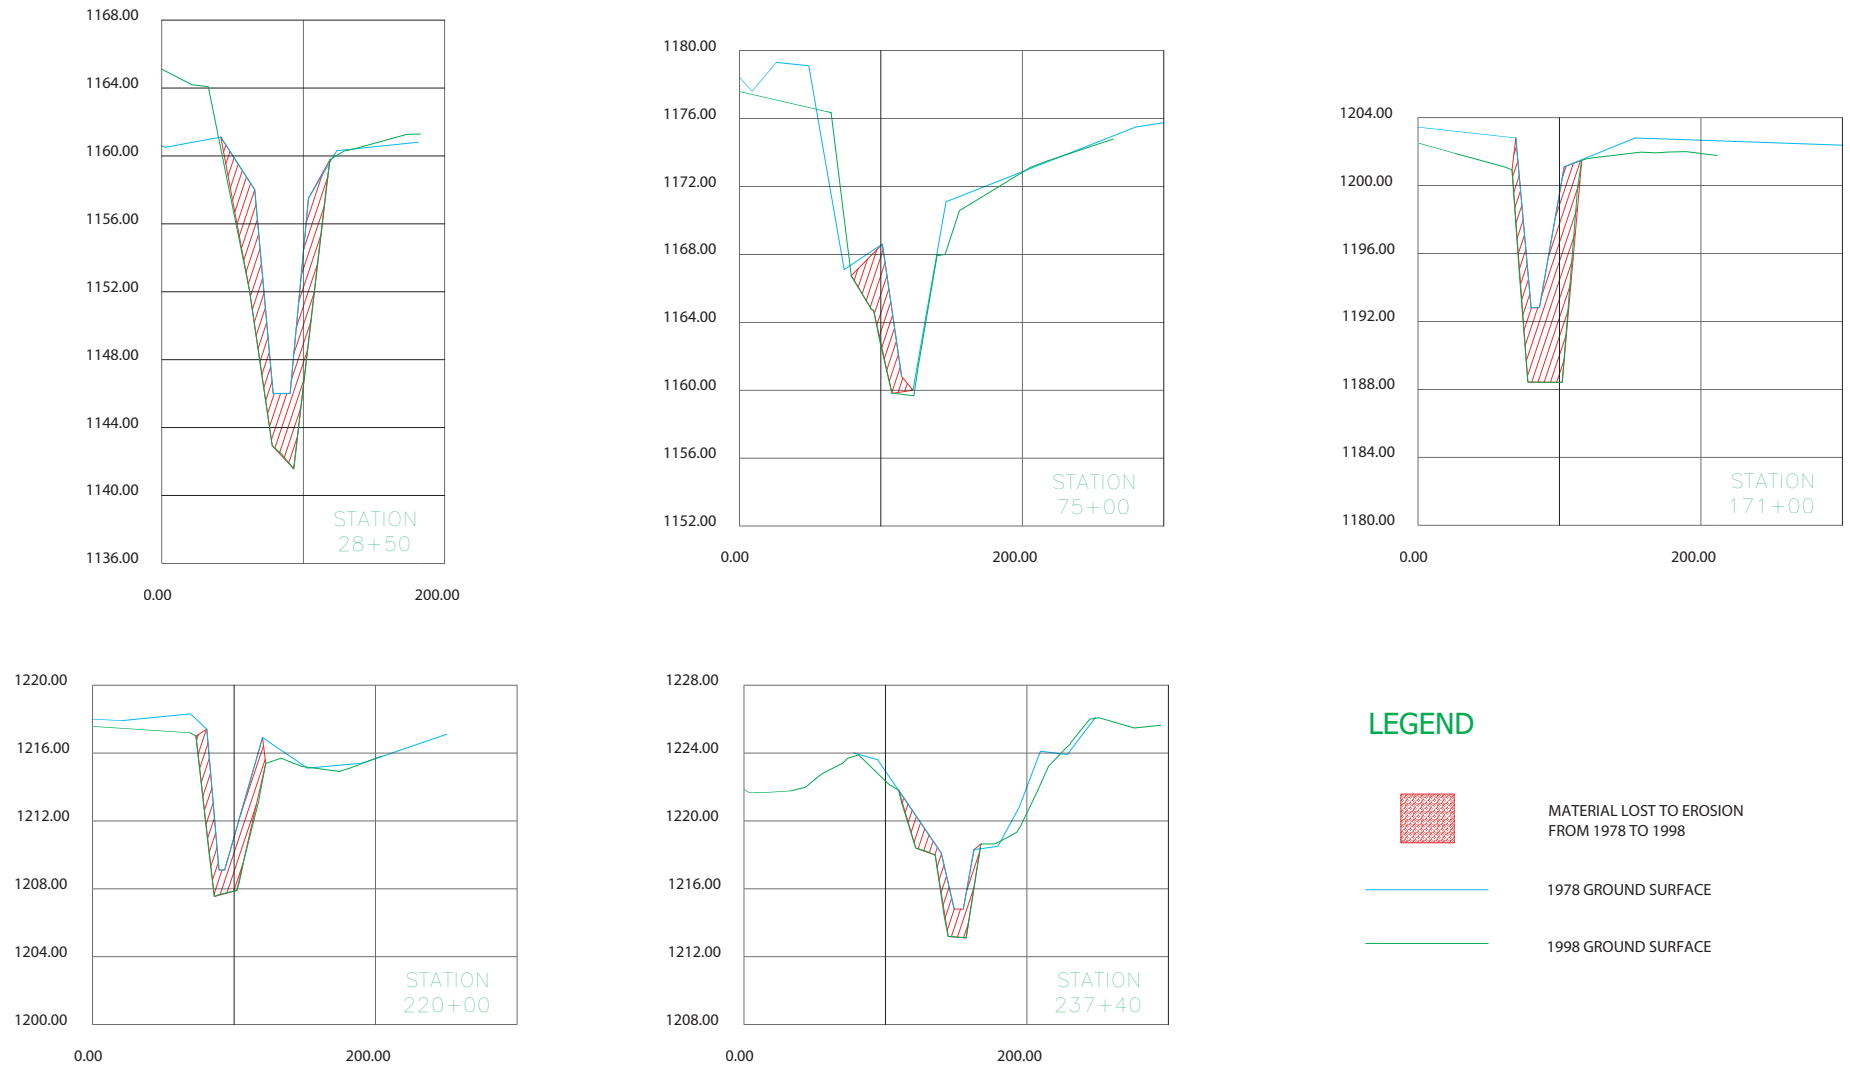
FIGURE I-12

It is estimated that approximately 200,000 cubic yards of soil have eroded from the Beal Slough channel reach between Salt Creek and Old Cheney Road in the past 25 years -- the equivalent of 12,000 dump truck loads. This information was based on a comparison of channel cross-sections surveyed for the 1978 FIS with surveys conducted at the same locations in 1997, see Figure I-12. The comparison revealed the following:

- Between Salt Creek and Highway 77, an average of two dump truck loads of soil has eroded from each foot of channel.
- Between 27<sup>th</sup> Street and Highway 2 near 38<sup>th</sup> Street nearly 10 cubic yards of soil has eroded from each foot of channel.

CHANNEL CROSS-SECTION  
COMPARISON BETWEEN FIS 1978 AND 1998
